**Flood Control Project Maintenance
Levee Inspections**

Maintenance Issue Types Only, Levee Inspection Report By Mile - Spring 2017

Marysville Levee Commission

Waterway	Bank	Unit Miles	Inspection Start/End	Inspector
Unit No. 01 Simmerly Slough	Left	3.23	04/12/2017 04/12/2017	Sterling York

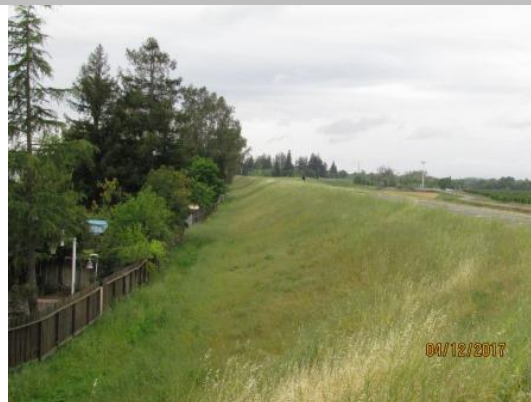
Photo 1 of 1 : SP_2017_NA0004_104_12_20170414_00023.jpg

LM Start	0.01	Rating **	M	Issue No.	12
LM End	3.19	Issue Type +	Ma	Location *	LS
Category	Earthen Levee			GPS Latitude/Longitude	
				Start	End
Item	Vegetation			39.149667 °	39.163847 °
				-121.601064 °	-121.560163 °
DWR ID	DWR_NA0004_01_s _ 2017_12				
Comment Code					
V1 : Control annual grass and weeds on the levee slopes and easements.					
Inspector Comment					
The crown shoulders have been mowed and sprayed but the slope annual grasses need to be maintained, Spring 2017.

View looking downstream of annual grasses, Spring 2017.

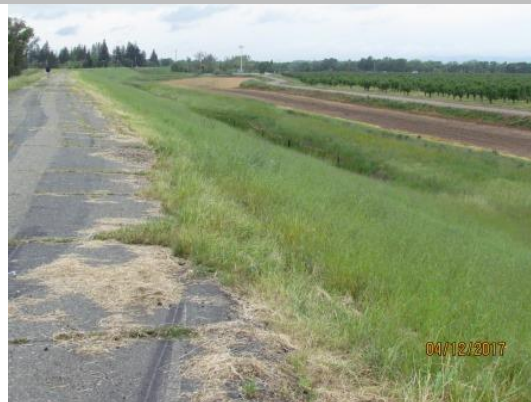
Photo 1 of 1 : SP_2017_NA0004_104_13_20170414_00024.jpg

LM Start	0.01	Rating **	M	Issue No.	13
LM End	3.19	Issue Type +	Ma	Location *	WS
Category	Earthen Levee			GPS Latitude/Longitude	
				Start	End
Item	Vegetation			39.149667 °	39.163844 °
				-121.601064 °	-121.560160 °
DWR ID	DWR_NA0004_01_s _ 2017_13				
Comment Code					
V1 : Control annual grass and weeds on the levee slopes and easements.					
Inspector Comment					
The crown shoulders have been mowed and sprayed but the slope annual grasses need to be maintained, Spring 2017.

View looking downstream of annual grasses, Spring 2017.

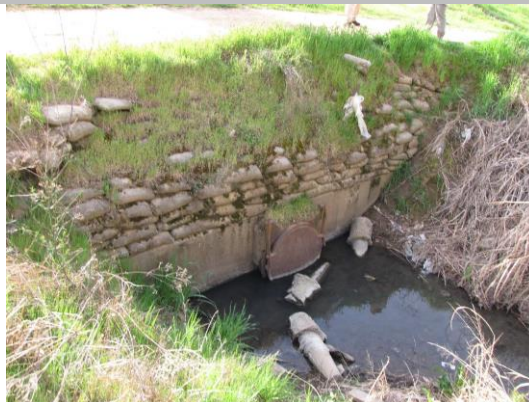
Photo 1 of 3 : UCIP_SP_2017_42945_69744.jpg

FS_ID:42945
DS_ID:19090
EP_NO: N/A
Repair Type: No Action Needed
Crossing Status: Found
UCIP Comments:
FIELD_STRUCT_DESC: 36-inch CM pipe through levee, 27.0 feet below crown. Flap gate and concrete "U" headwall on waterward end. Slide gate in 48-inch Corrugated metal riser on waterward slope of pipe. Steel walkway to control gate. Outfall drains from Ellis Lake. Concrete headwall at both toes. Concrete base under riser units. (USACE-1955). This entry matches the Drainage or Irrigation Structure referenced in O&M manual (Station 8+48). Steel riser unit & slide gate added under Permit No. 4041.
FS Date: 3/14/2013

View of outlet located on waterward side under toe road.

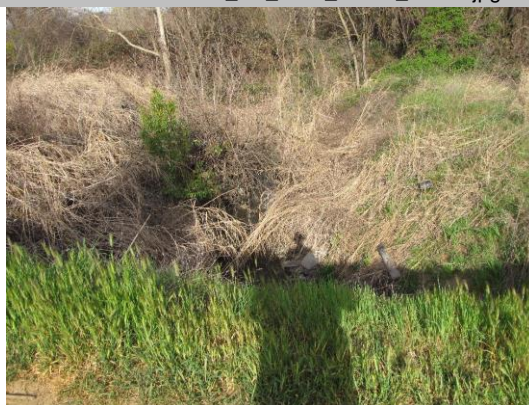
Photo 2 of 3 : UCIP_SP_2017_42945_69743.jpg

View of waterward side from toe road.

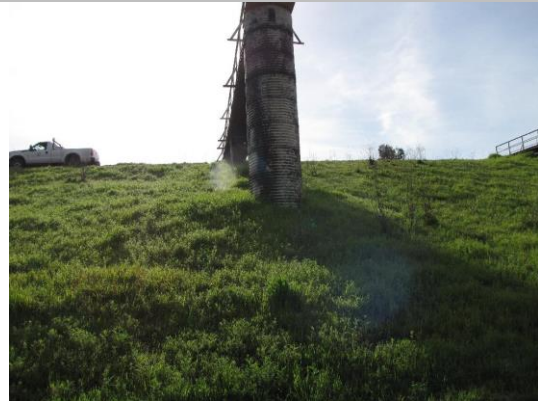
Photo 3 of 3 : UCIP_SP_2017_42945_69742.jpg

View of waterward slope.

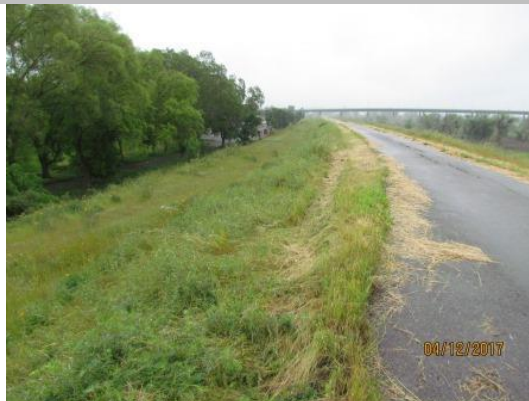
Photo 1 of 1 : SP_2017_NA0004_105_5_20170414_00017.jpg

LM Start	0.00	Rating **	M	Issue No.	5
LM End	1.23	Issue Type +	Ma	Location *	LS
Category	Earthen Levee			GPS Latitude/Longitude	
				Start	End
Item	Vegetation			39.149516 °	39.134731 °
				-121.601097 °	-121.594001 °
DWR ID	DWR_NA0004_02_s _ 2017_5				
Comment Code					
V1 : Control annual grass and weeds on the levee slopes and easements.					
Inspector Comment					
The crown shoulders have been mowed and sprayed but the slope annual grasses need to be maintained, Spring 2017.

View looking downstream of annual grasses, Spring 2016.

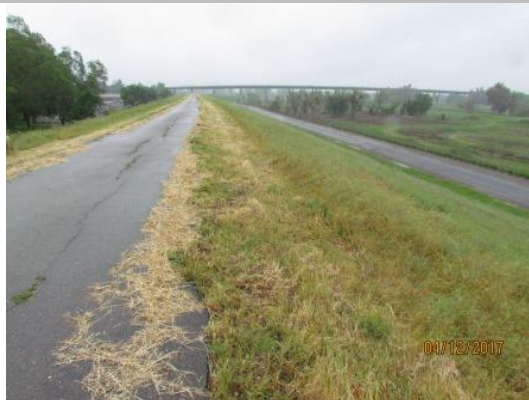
Photo 1 of 1 : SP_2017_NA0004_105_7_20170414_00018.jpg

LM Start	0.00	Rating **	M	Issue No.	7
LM End	1.23	Issue Type +	Ma	Location *	WS
Category	Earthen Levee			GPS Latitude/Longitude	
				Start	End
Item	Vegetation			39.149514 °	39.134731 °
				-121.601097 °	-121.594001 °
DWR ID	DWR_NA0004_02_s _ 2017_7				
Comment Code					
V1 : Control annual grass and weeds on the levee slopes and easements.					
Inspector Comment					
The crown shoulders have been mowed and sprayed but the slope annual grasses need to be maintained, Spring 2017.

View looking downstream of annual grasses, Spring 2016.

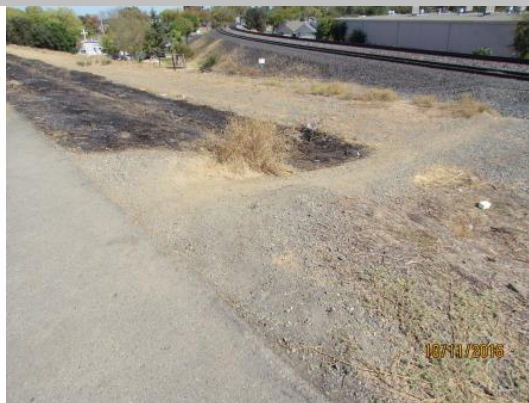
Photo 1 of 1 : SP_2017_NA0004_105_8_20170316_00003.jpg

LM Start	0.22	Rating **	M	Issue No.	8
LM End	0.22	Issue Type +	Ma	Location *	LS
Category	Earthen Levee			GPS Latitude/Longitude	
				Start	End
Item	Slope Stability			39.146352 °	39.146352 °
				-121.600724 °	-121.600724 °
DWR ID	DWR_NA0004_02_f_2016_8				
Comment Code					
S2 : Repair the levee slope damaged by foot traffic and prevent access where possible.					
Inspector Comment					
Foot path depression in the landside levee slope needs repaired. Fall 2016.

View of foot path depression in the landside levee slope.

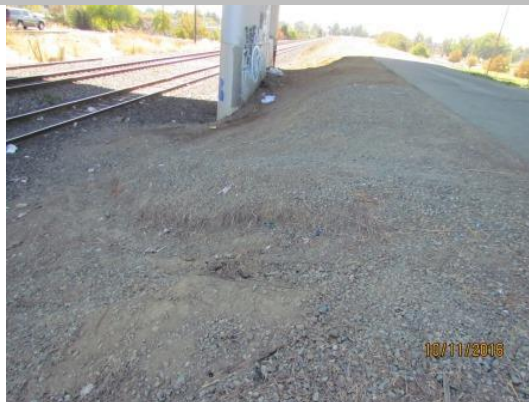
Photo 1 of 1 : SP_2017_NA0004_105_6_20170316_00002.jpg

LM Start	0.31	Rating **	A/W	Issue No.	6
LM End	0.31	Issue Type +	Ma	Location *	LS
Category	Earthen Levee			GPS Latitude/Longitude	
				Start	End
Item	Slope Stability			39.144990 °	39.144990 °
				-121.600576 °	-121.600576 °
DWR ID	DWR_NA0004_02_s_2015_6				
Comment Code					
S2 : Repair the levee slope damaged by foot traffic and prevent access where possible.					
Inspector Comment					
Tire ruts in the landside levee slope has been repaired, Spring 2017.

View of tire ruts in the landside levee slope. For Spring 2017 the rut depressions in the landside levee slope has been repaired.

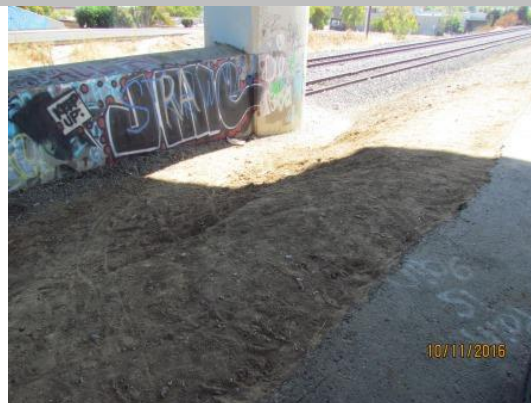
Photo 1 of 1 : SP_2017_NA0004_105_4_20170316_00001.jpg

LM Start	0.32	Rating **	A/W	Issue No.	4
LM End	0.32	Issue Type +	Ma	Location *	LS
Category	Earthen Levee			GPS Latitude/Longitude	
				Start	End
Item	Slope Stability			39.144840 °	39.144840 °
				-121.600559 °	-121.600559 °
DWR ID	DWR_NA0004_02_s_2016_4				
Comment Code					
S2 : Repair the levee slope damaged by foot traffic and prevent access where possible.					
Inspector Comment					
Foot path depression in the landside levee slope has been repaired, Spring 2017.

View looking downstream of landside slope erosion due to heavy foot traffic. Fall 2016. For Spring 2017 the foot path depression in the landside levee slope has been repaired.

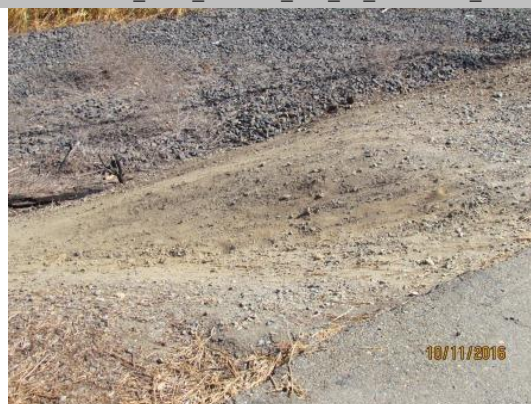
Photo 1 of 1 : SP_2017_NA0004_105_13_20170316_00008.jpg

LM Start	0.82	Rating **	M	Issue No.	13
LM End	0.82	Issue Type +	Ma	Location *	LS
Category	Earthen Levee			GPS Latitude/Longitude	
				Start	End
Item	Slope Stability			39.138827 °	39.138827 °
				-121.599530 °	-121.599530 °
DWR ID	DWR_NA0004_02_f_2016_13				
Comment Code					
S2 : Repair the levee slope damaged by foot traffic and prevent access where possible.					
Inspector Comment					
Foot path depression in the landside levee slope needs repaired.

View of foot path depression in the landside levee slope.

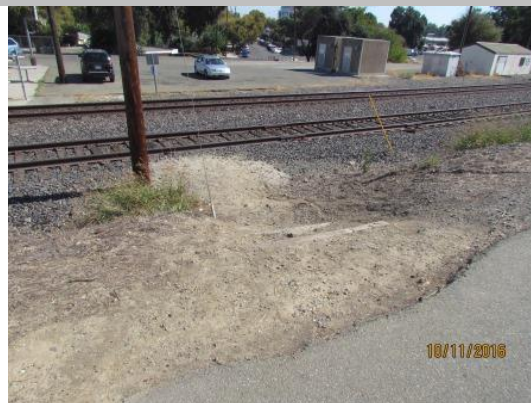
Photo 1 of 1 : SP_2017_NA0004_105_14_20170316_00009.jpg

LM Start	0.85	Rating **	M	Issue No.	14
LM End	0.85	Issue Type +	Ma	Location *	LS
Category	Earthen Levee			GPS Latitude/Longitude	
				Start	End
Item	Slope Stability			39.138463 °	39.138463 °
				-121.599168 °	-121.599168 °
DWR ID	DWR_NA0004_02_f_2016_14				
Comment Code					
S2 : Repair the levee slope damaged by foot traffic and prevent access where possible.					
Inspector Comment					
Remove steps that are cut into levee slope.

View of steps for foot path in the landside levee slope.

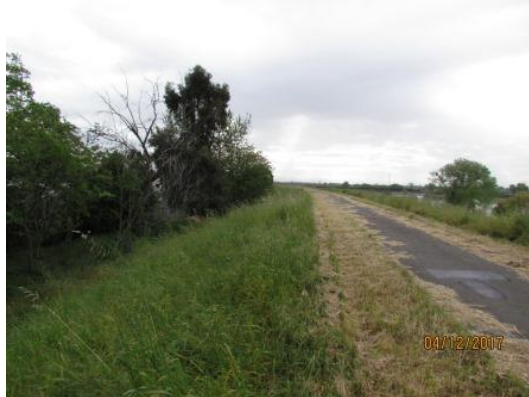
Photo 1 of 1 : SP_2017_NA0004_106_29_20170414_00069.jpg

LM Start	0.43	Rating **	M	Issue No.	29
LM End	4.82	Issue Type +	Ma	Location *	LS
Category	Earthen Levee			GPS Latitude/Longitude	
				Start	End
Item	Vegetation			39.135454 °	39.185223 °
				-121.586080 °	-121.540193 °
DWR ID	DWR_NA0004_03_f_2016_29				
Comment Code					
V1 : Control annual grass and weeds on the levee slopes and easements.					
Inspector Comment					
Annual vegetation needs to be Maintained the crown and shoulders have been mowed and sprayed, Spring 2017.

View looking upstream of the landside slope where the annual vegetation maintenance needs to be completed. Spring 2017.

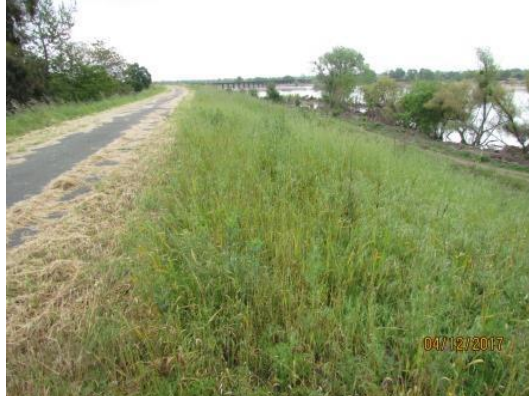
Photo 1 of 1 : SP_2017_NA0004_106_27_20170414_00070.jpg

LM Start	0.43	Rating **	M	Issue No.	27
LM End	4.82	Issue Type +	Ma	Location *	WS
Category	Earthen Levee			GPS Latitude/Longitude	
				Start	End
Item	Vegetation			39.135454 °	39.185223 °
				-121.586079 °	-121.540193 °
DWR ID	DWR_NA0004_03_f_2016_27				
Comment Code					
V1 : Control annual grass and weeds on the levee slopes and easements.					
Inspector Comment					
Annual vegetation needs to be Maintained the crown and shoulders have been mowed and sprayed, Spring 2017.

View looking upstream of the waterside slope where the annual vegetation maintenance needs to be completed. Spring 2017.

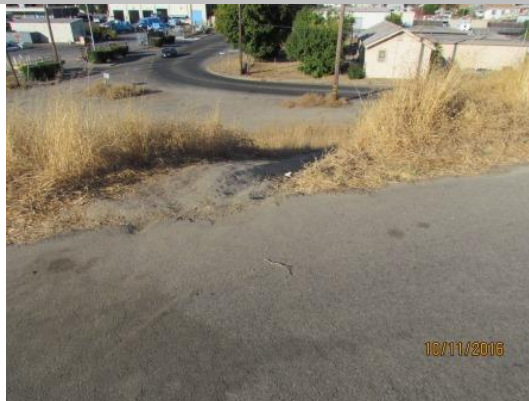
Photo 1 of 1 : SP_2017_NA0004_106_30_20170316_00011.jpg

LM Start	1.00	Rating **	M	Issue No.	30
LM End	1.00	Issue Type +	Ma	Location *	LS
Category	Earthen Levee			GPS Latitude/Longitude	
				Start	End
Item	Erosion / Bank Caving			39.142167 °	39.142167 °
				-121.582817 °	-121.582817 °
DWR ID	DWR_NA0004_03_f_2016_30				
Comment Code					
E1 : Note and monitor erosion site.					
Inspector Comment					
Path cut in by foot traffic on the landside slope needs repaired.

View of path cut in by foot traffic on the landside slope.

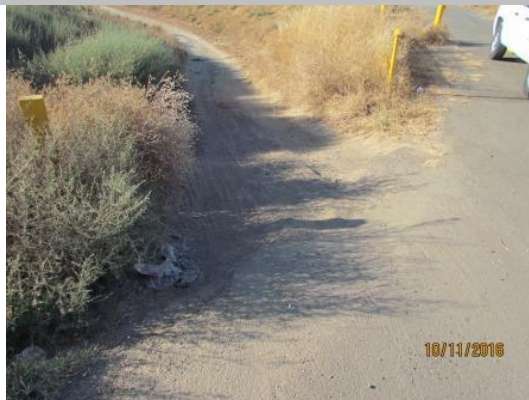
Photo 1 of 1 : SP_2017_NA0004_106_32_20170316_00012.jpg

LM Start	1.16	Rating **	M	Issue No.	32	
LM End	1.16	Issue Type +	Ma	Location *	WS	
Category	Earthen Levee			GPS Latitude/Longitude		
				Start		End
Item	Slope Stability			39.144392 °		39.144392 °
				-121.582930 °		-121.582930 °
DWR ID	DWR_NA0004_03_f_2016_32					
Comment Code						
S3 : Repair the levee slope damaged by vehicle traffic and prevent access where possible.						
Inspector Comment						
Ruts cut in by vehicle traffic on the landside slope needs repaired.

View of ruts cut in by vehicle traffic on the waterside slope.

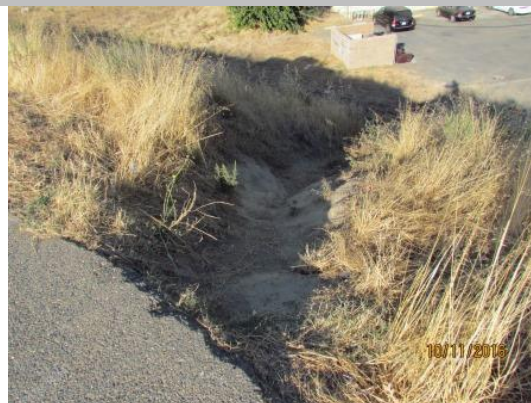
Photo 1 of 1 : SP_2017_NA0004_106_33_20170316_00013.jpg

LM Start	1.28	Rating **	M	Issue No.	33
LM End	1.28	Issue Type +	Ma	Location *	LS
Category	Earthen Levee			GPS Latitude/Longitude	
				Start	End
Item	Slope Stability			39.145723 °	39.145723 °
				-121.581323 °	-121.581323 °
DWR ID	DWR_NA0004_03_f_2016_33				
Comment Code					
S2 : Repair the levee slope damaged by foot traffic and prevent access where possible.					
Inspector Comment					
Path cut in by foot traffic on the landside slope needs repaired.

View of path cut in by foot traffic on the landside slope that needs repaired.

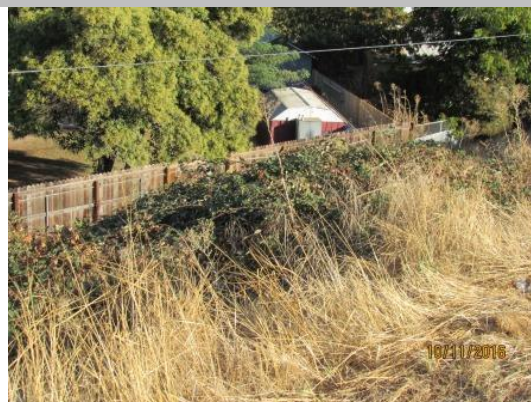
Photo 1 of 1 : SP_2017_NA0004_106_36_20170316_00016.jpg

LM Start	1.40	Rating **	M	Issue No.	36
LM End	1.40	Issue Type +	Ma	Location *	LS
Category	Earthen Levee			GPS Latitude/Longitude	
				Start	End
Item	Vegetation			39.146963 °	39.146963 °
				-121.579830 °	-121.579830 °
DWR ID	DWR_NA0004_03_f_2016_36				
Comment Code					
V2 : Remove the wild growth other than native grasses from the levee slopes.					
Inspector Comment					
Blackberry bush on slope needs to be removed.

View of Blackberry bush that is covering landside levee slope.

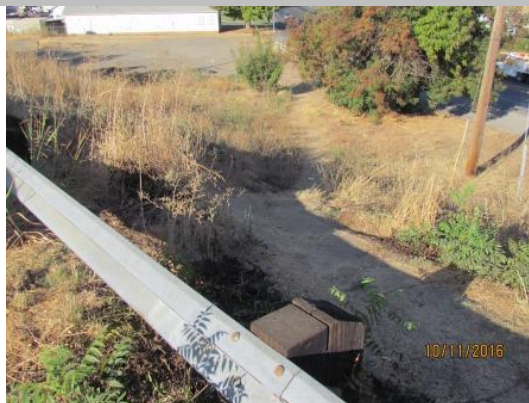
Photo 1 of 1 : SP_2017_NA0004_106_18_20170316_00006.jpg

LM Start	1.61	Rating **	M	Issue No.	18
LM End	1.61	Issue Type +	Ma	Location *	LS
Category	Earthen Levee			GPS Latitude/Longitude	
				Start	End
Item	Slope Stability			39.149098 °	39.149098 °
				-121.577162 °	-121.577162 °
DWR ID	DWR_NA0004_03_f_2016_18				
Comment Code					
S2 : Repair the levee slope damaged by foot traffic and prevent access where possible.					
Inspector Comment					
Foot path need to be repaired.

View of foot path that has cut into landside levee slope.

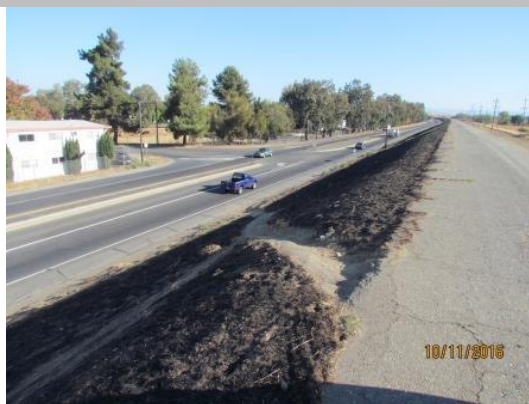
Photo 1 of 1 : SP_2017_NA0004_106_39_20170316_00017.jpg

LM Start	2.15	Rating **	M	Issue No.	39
LM End	2.15	Issue Type +	Ma	Location *	LS
Category	Earthen Levee			GPS Latitude/Longitude	
				Start	End
Item	Slope Stability			39.154440 °	39.154440 °
				-121.569839 °	-121.569839 °
DWR ID	DWR_NA0004_03_f_2016_39				
Comment Code					
S2 : Repair the levee slope damaged by foot traffic and prevent access where possible.					
Inspector Comment					
Foot path need to be repaired.

View looking upstream of foot path that has cut into the landside levee slope.

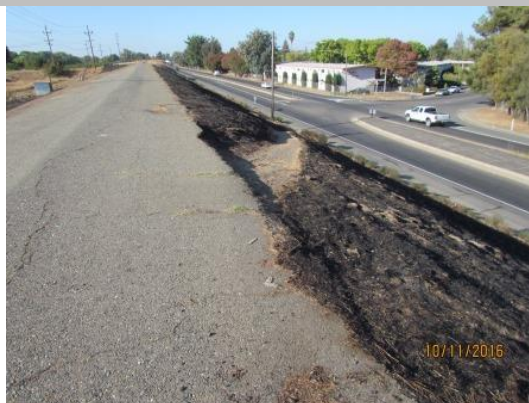
Photo 1 of 1 : SP_2017_NA0004_106_40_20170316_00018.jpg

LM Start	2.21	Rating **	M	Issue No.	40
LM End	2.21	Issue Type +	Ma	Location *	LS
Category	Earthen Levee			GPS Latitude/Longitude	
				Start	End
Item	Slope Stability			39.155076 °	39.155076 °
				-121.568970 °	-121.568970 °
DWR ID	DWR_NA0004_03_f_2016_40				
Comment Code					
S2 : Repair the levee slope damaged by foot traffic and prevent access where possible.					
Inspector Comment					
Foot path need to be repaired.

View looking downstream of foot path that has cut into the landside levee slope.

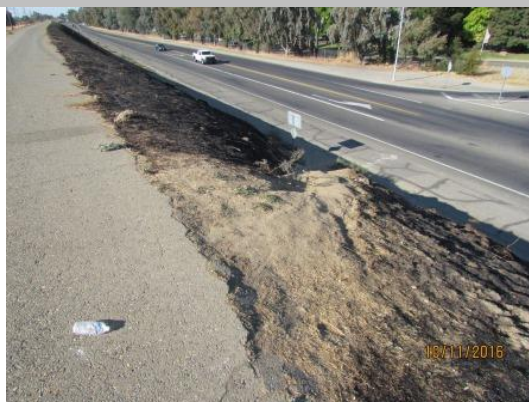
Photo 1 of 1 : SP_2017_NA0004_106_41_20170316_00019.jpg

LM Start	2.55	Rating **	M	Issue No.	41
LM End	2.55	Issue Type +	Ma	Location *	LS
Category	Earthen Levee			GPS Latitude/Longitude	
				Start	End
Item	Slope Stability			39.158509 °	39.158509 °
				-121.564423 °	-121.564423 °
DWR ID	DWR_NA0004_03_f_2016_41				
Comment Code					
S2 : Repair the levee slope damaged by foot traffic and prevent access where possible.					
Inspector Comment					
Foot path need to be repaired.

View looking downstream of foot path that has cut into the landside levee slope.

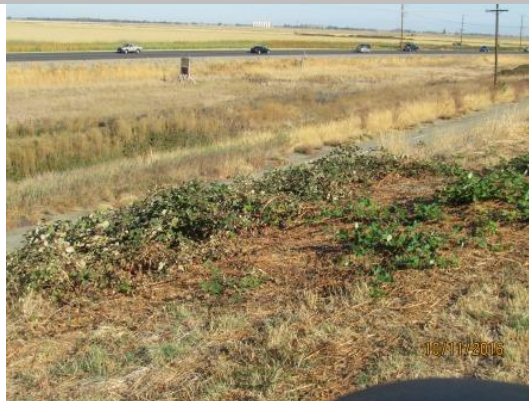
Photo 1 of 1 : SP_2017_NA0004_106_34_20170316_00014.jpg

LM Start	4.58	Rating **	M	Issue No.	34
LM End	4.58	Issue Type +	Ma	Location *	LS
Category	Earthen Levee			GPS Latitude/Longitude	
				Start	End
Item	Vegetation			39.182347 °	39.182347 °
				-121.542744 °	-121.542744 °
DWR ID	DWR_NA0004_03_f_2013_34				
Comment Code					
V2 : Remove the wild growth other than native grasses from the levee slopes.					
Inspector Comment					
Blackberries on landward levee slope.

View of Black berries that are starting to cover landside slope, looking upstream.

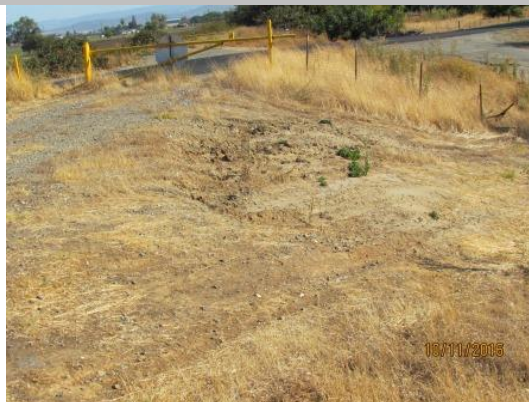
Photo 1 of 1 : SP_2017_NA0004_106_44_20170316_00022.jpg

LM Start	4.81	Rating **	M	Issue No.	44
LM End	4.81	Issue Type +	Ma	Location *	WS
Category	Earthen Levee			GPS Latitude/Longitude	
				Start	End
Item	Slope Stability			39.185108 °	39.185108 °
				-121.540411 °	-121.540411 °
DWR ID	DWR_NA0004_03_f_2016_44				
Comment Code					
S3 : Repair the levee slope damaged by vehicle traffic and prevent access where possible.					
Inspector Comment					
Vehicle ruts on slope need to be repaired.

View looking upstream of vehicle ruts on waterside slope.
